## Commercial Roof-top Units in Minnesota

### Characteristics and Energy Performance

**Conservation Applied Research & Development (CARD)  
FINAL REPORT**

**Prepared by: Seventhwave and Center for Energy and Environment**

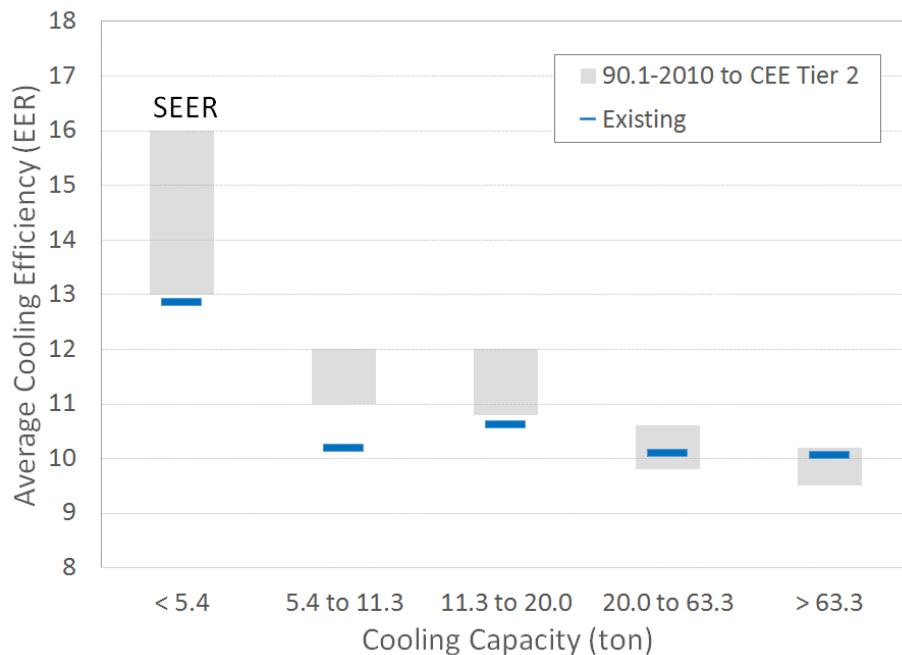
**Figure 2: Average cooling efficiency by cooling capacity.**

The average existing RTU cooling efficiencies are plotted as bars, while the range of cooling efficiency between the current Minnesota energy code [2] and the Consortium for Energy Efficiency's (CEE) Tier 2 [3] recommendations are also shown to illustrate the potential programmatic savings magnitude. For RTUs with cooling capacities below 20 tons, the average existing efficiency is below the code-minimum and well-below the CEE Tier 2 recommendation suggesting that there is considerable opportunity for improved efficiency in smaller RTUs. For larger RTUs with cooling capacities between 20 and 63.3 tons, the average existing efficiency is between the code-minimum requirement and below the CEE Tier 2 recommendation. This suggests that there is a limited opportunity for increasing efficiency for RTUs in this capacity range, as their efficiency is already relatively high. For RTUs with cooling capacities above 63.3 tons, the average existing efficiency is near the CEE Tier 2 recommendation leaving little opportunity for increased efficiency. For historical context, Table 1 outlines the average existing RTU cooling efficiency as well as the code-required minimum cooling efficiencies across the previous four ASHRAE 90.1 building energy codes. [4]

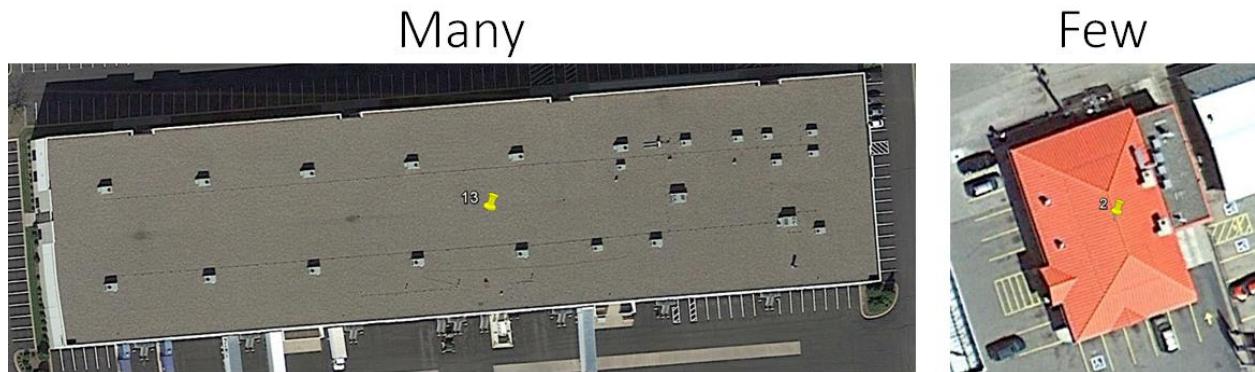
**Figure 4: Example aerial imagery of buildings with RTUs.**

We were careful not to count equipment on rooftops that looked like RTUs but were not. For air handling units, mechanical penthouses and split systems this was relatively straightforward. Other questionable units were flagged and an audit of all flags was conducted by an experienced mechanical engineer to make the final determination of whether the unit was actually an RTU. However, due to the nature of remote data collection, we occasionally mistakenly counted things that were not in fact RTUs, such as heating-only or make-up air units. We took steps to address these potential non-RTUs in our estimates as discussed in more detail in Appendix A: Sampling and Weighting. We also did not count RTUs that served non-commercial facilities such as multifamily buildings.

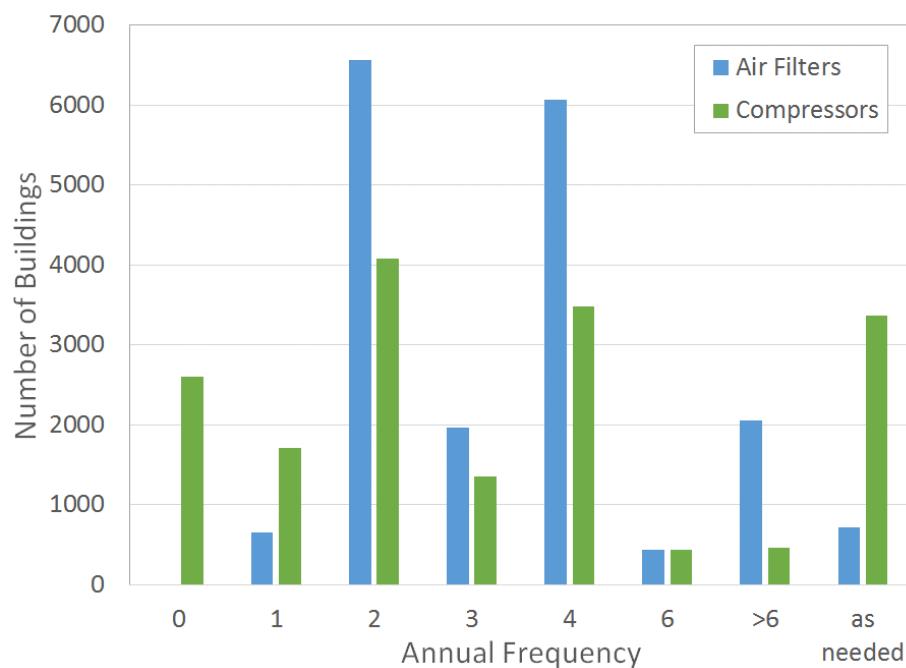
**Figure 17: Annual frequency of air filter replacement and compressor cleaning.**

The best practice for replacing air filters is to track the pressure drop across the filter and replace the filter when the pressure drop exceeds some threshold when it becomes too dirty. A more common recommendation is that air filters be changed on a quarterly basis or four times each year. Nearly half (46%) of buildings had their air filters changed at this level of frequency or above. In some cases, higher frequency was driven by site-specific needs such as very dusty adjacent parking lots. Compressors were less likely to be cleaned on a frequent basis with over one-third (34%) never being cleaned or only being cleaned as needed.

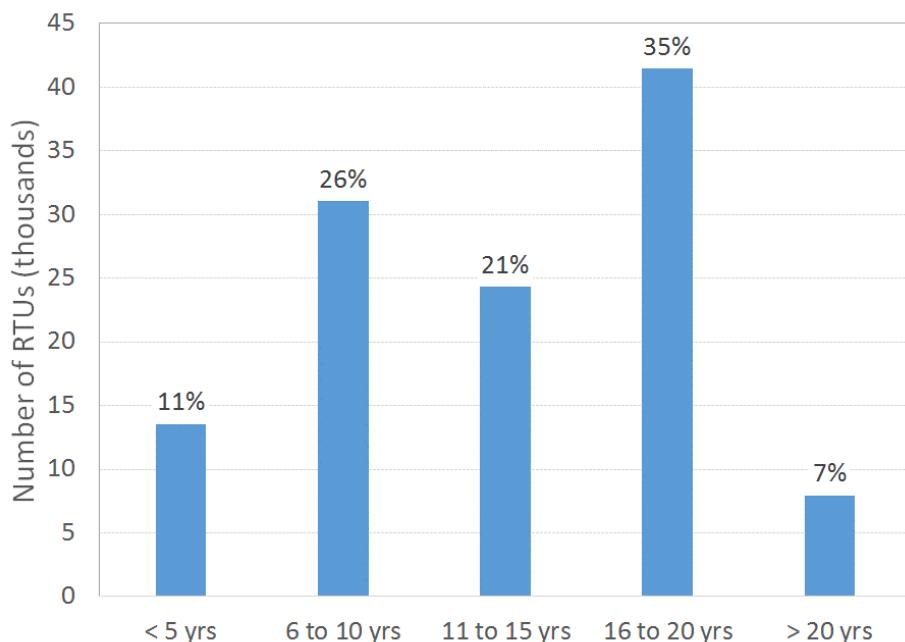
The age of RTUs also has an impact on energy performance because newer RTUs may have higher efficiencies and system performance tends to degrade over time. Figure 19 shows the portion of existing RTUs falling into different age ranges.

Note that it was increasingly difficult to find the age of older RTUs, meaning the accuracy of estimates becomes increasingly less precise as RTU age increases. **The average age of an existing RTU in Minnesota is 13.1 years.** Newer RTUs, those that are less than 5 years old, comprise 11% of existing RTUs. Also, only 7% of existing RTUs are older than the Minnesota TRM's value of 20 years for estimated useful life.

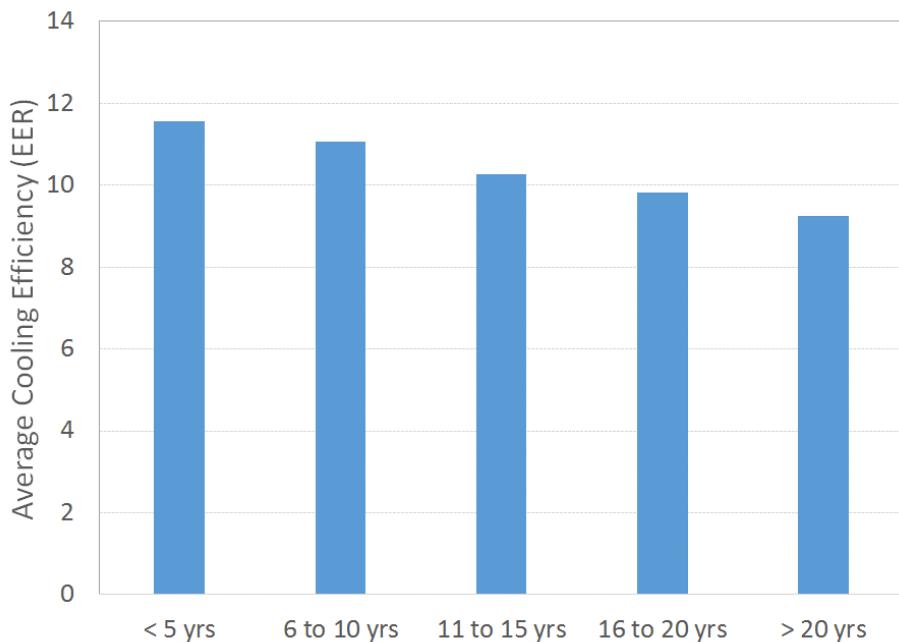
Note the clear trend of increasing cooling efficiency in newer RTUs. In fact, over the last 20 years, the average cooling efficiency of RTUs has increased by 18%.

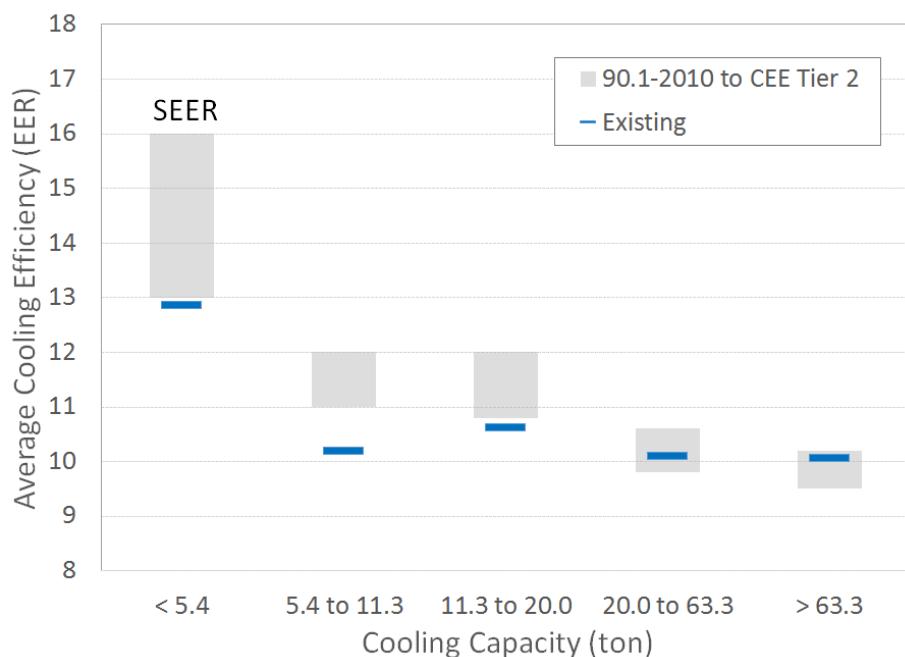
For cooling capacities above 5.4 ton, the cooling efficiency is expressed as EER, while the cooling efficiency for capacities below 5.4 ton is expressed as SEER. As opposed to previous graphs, the existing RTU data are plotted as bars. Additionally, the range of cooling efficiency between the current Minnesota energy code [12] and CEE's Tier 2 [13] recommendations are also plotted to illustrate the potential programmatic savings magnitude. CEE's Tier 1 efficiency recommendations are defined at a performance level corresponding to price points with significant sales volume. CEE's Tier 2 is defined to provide significant, but achievable, savings above and beyond Tier 1.

In RTUs with cooling capacities below 20 tons, the average existing efficiency is below the code-minimum and well-below the CEE Tier 2 recommendation, suggesting considerable opportunity for improved efficiency in smaller RTUs. For larger RTUs with cooling capacities between 20 and 63.5 ton, the average existing efficiency is between the code-minimum requirement and below the CEE Tier 2 recommendation. Since their efficiency is already relatively high, there is a limited opportunity for increasing efficiency. For the largest capacity RTUs with cooling capacities above 63.3 ton, the average existing efficiency is near the CEE Tier 2 recommendation, leaving little opportunity for increased efficiency.

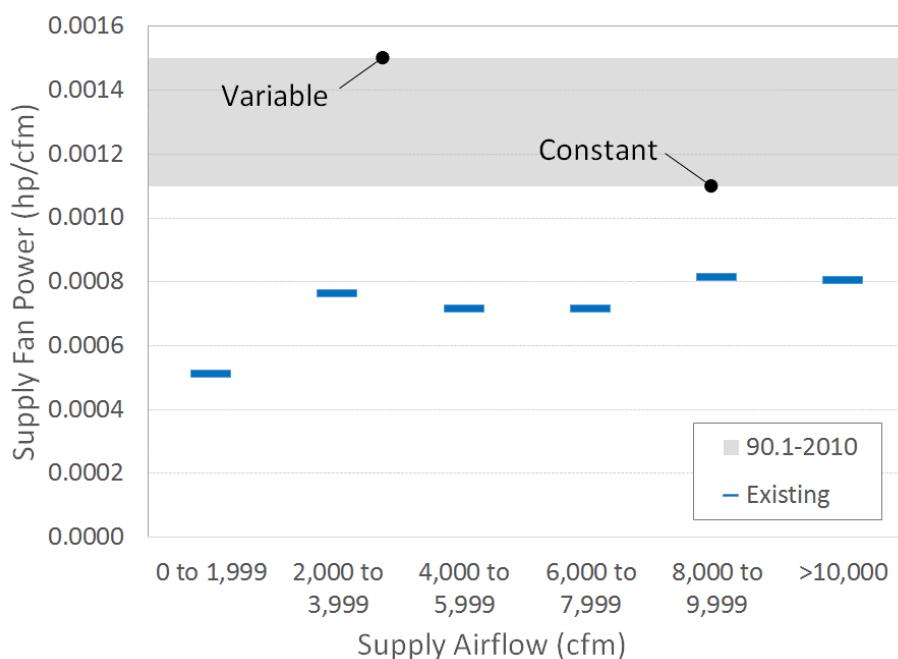
The Minnesota energy code maximum [16] requirements are also illustrated for both constant speed (the predominant type) and variable speed fans. For all supply airflows, the fan power is below code-required maximum values, indicating that there is less program potential for increasing fan power efficiency on RTUs.

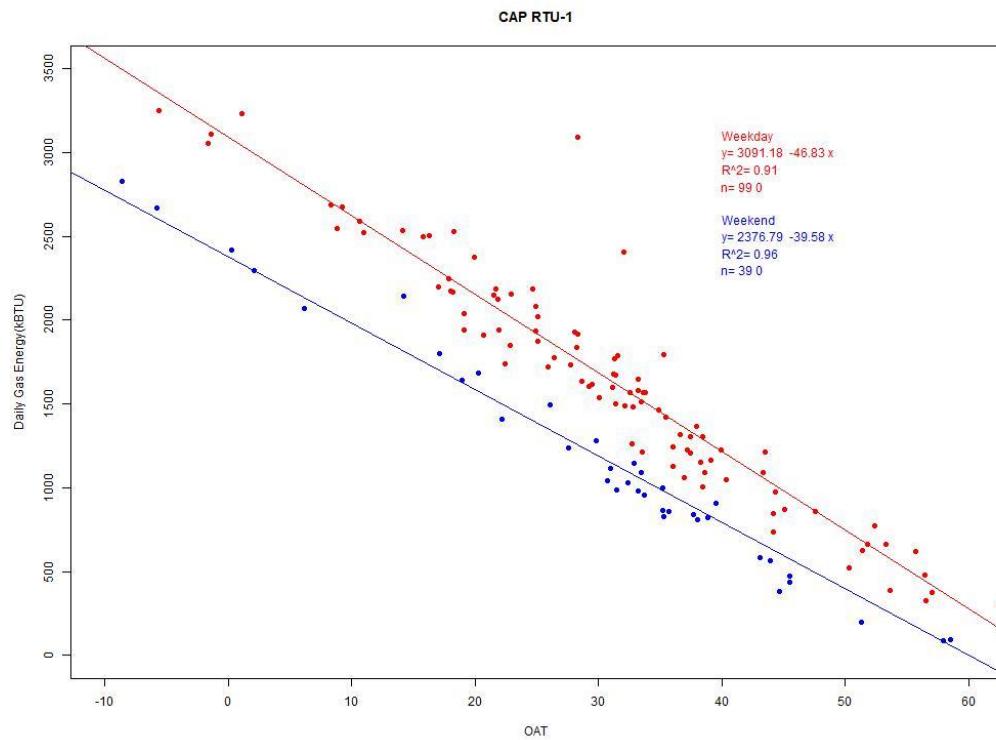
Figure 42 represents an ideal consumption model with a different model for weekday and weekend periods. The weekday period model has a good regression fit with an  $R^2$  of 91% while the weekend model shows lower gas consumption at the same outside air temperature. The weekend regression model is also a good fit with an  $R^2$  of 96%. The RTU at this site is controlled by a 7-day programmable thermostat that can't be modified by the occupants so it results in the clean models displayed in the figure. One interesting observation is the area served by this RTU requires heating to an outside air temperature of over 60 degrees F, much higher than the typical commercial office building which usually reaches balance point at 50 degrees F.

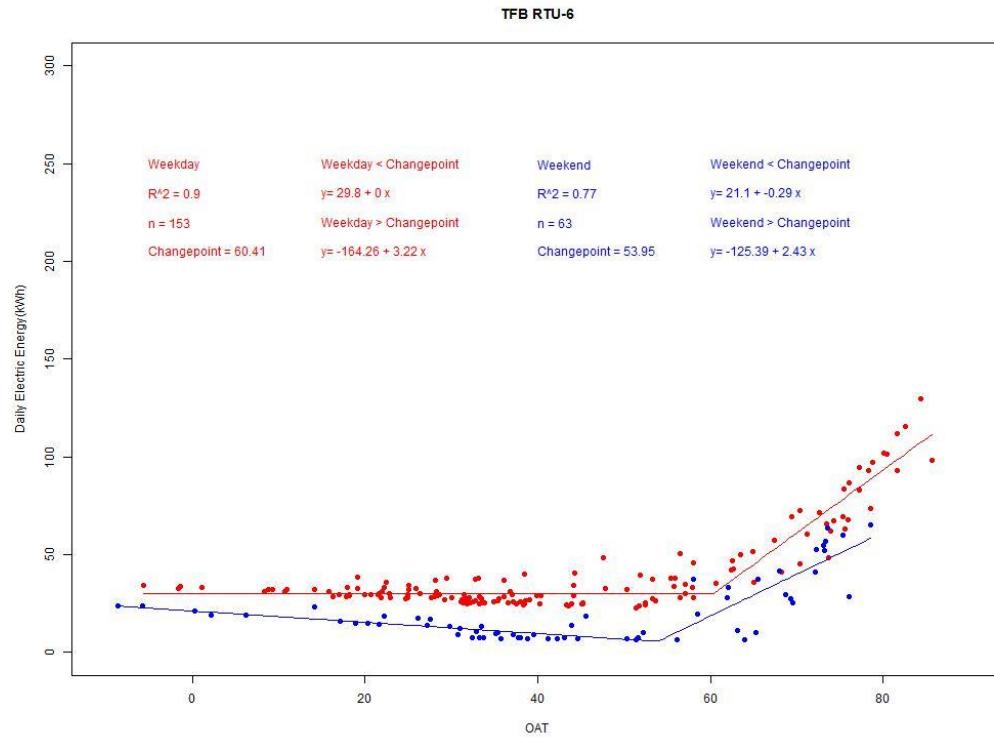
Figure 47 displays a non-typical electric consumption model. There is no difference between the weekday or weekend consumption models as one would expect for a site with a programmable thermostat. This is an office that doesn't have weekend office hours, which should result in lower RTU electric use during the unoccupied periods. The models are slightly different but not enough to assume that the weekend setpoints are different than the weekday.

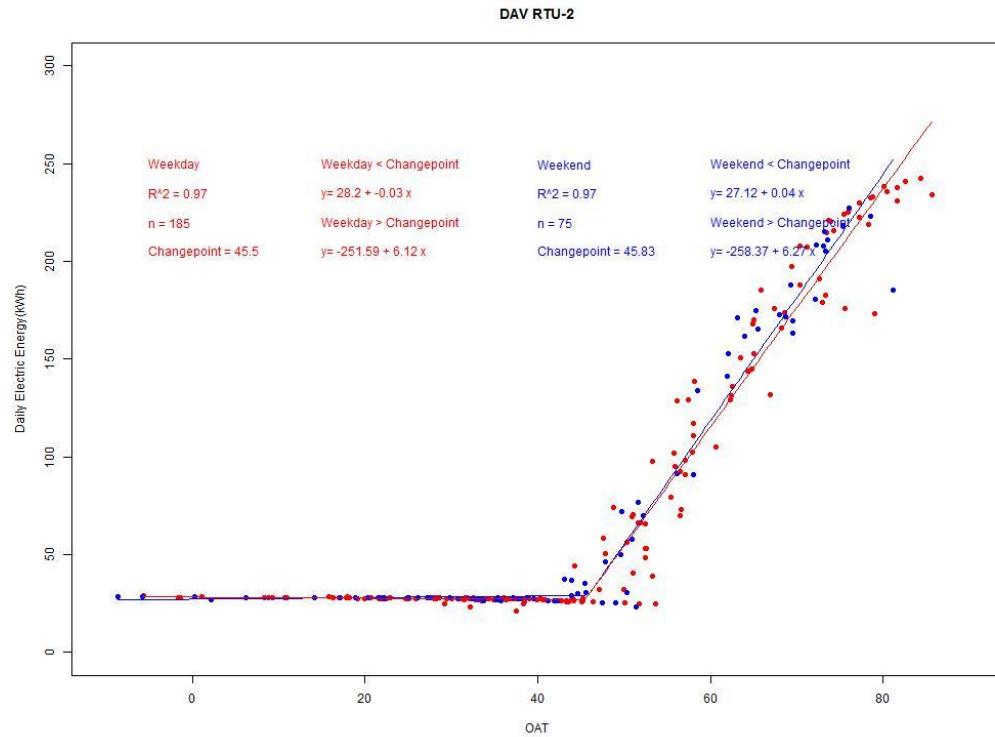
If the economizer were operating correctly for RTU #2 at DAV, there wouldn't be the increase in electric energy at an outside air temperature of 45 degrees. The mechanical cooling on this RTU should be kept off to at least 60, if not 65, degrees outside air temperature, at which time the compressor would need to be utilized to provide cooling to the space.

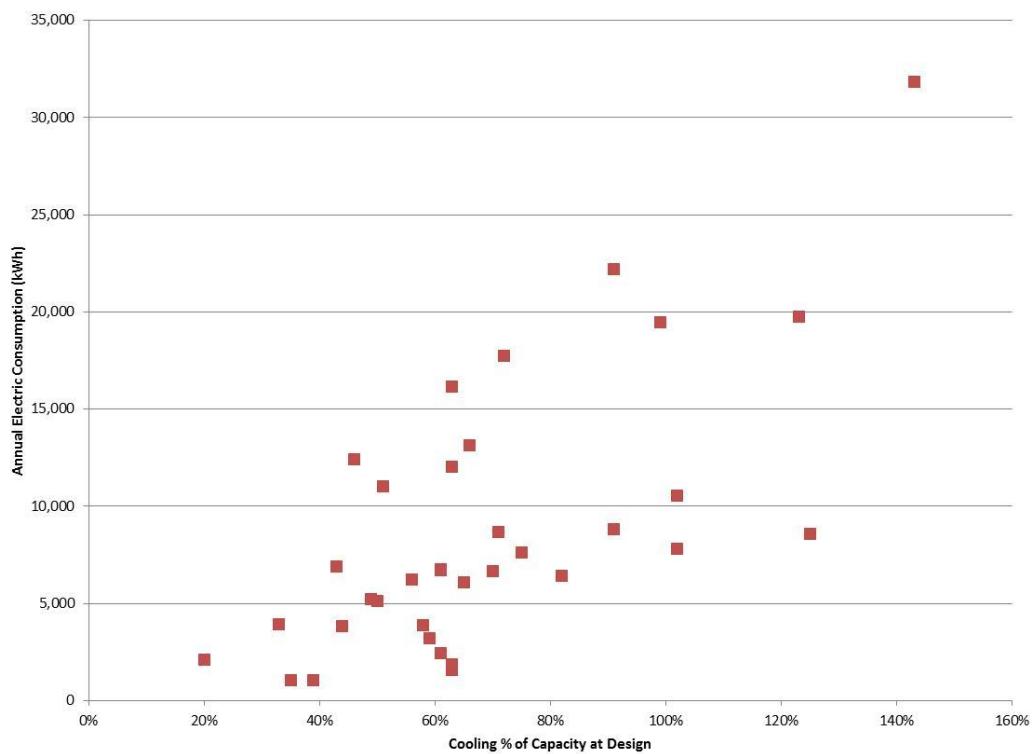
**Figure 52: Annual Electric Consumption as a Function of Sizing**

As seen in Figure 51, RTU heating capacity is generally more oversized than cooling. This is visually represented by more RTUs having the computed value of heating percent of capacity at design of less than 50%. The same is not true for the cooling sizing. More RTUs are near their design capacity at design outside air conditions.
